**REPORT BY THE MINISTER OF POLICE TO  
PARLIAMENT ON**

**SECURITY UPGRADES AT THE NKANDLA PRIVATE  
RESIDENCE OF THE PRESIDENT**

**25 March 2015**

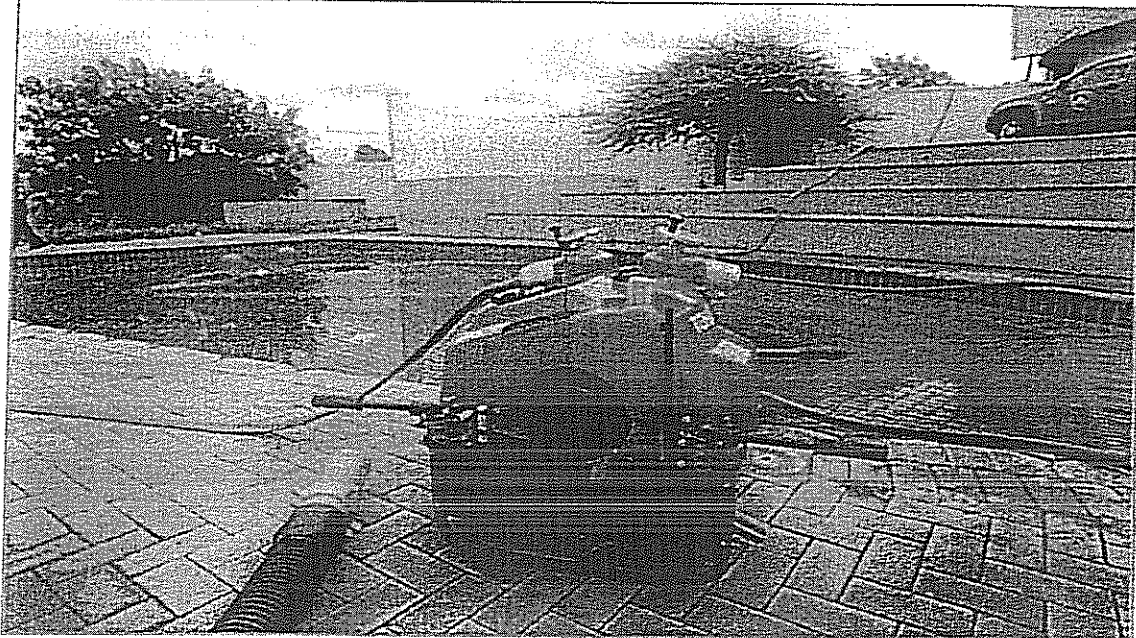
Figure 2: Fire pool/ swimming pool use for fire fighting

6.2.4 The pictures below illustrate how the fire pool and/or swimming pool is operated during fire fighting.

6.2.6 To provide onsite complementary firefighting equipment the suction pump with 1500L a minute capacity and monitors with 16 centimeter diameter hose, 50 meters long is permanently attached to the pool, for any fire emergency. This capacity is useful to extinguish fire while the fire truck is on the way. It can also refill the fire truck during firefighting operation.

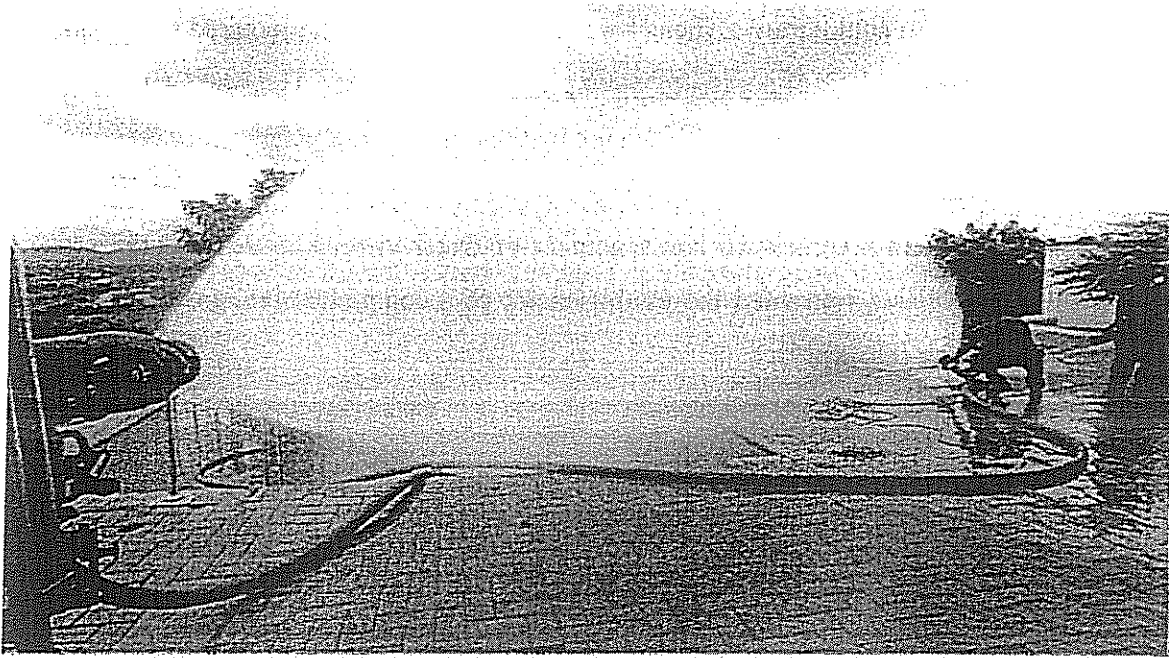
Figure 3: Firefighting demonstration

6.2.14 The fire expert concluded, as per the attached Annexure, that the best water source that is available on site at Nkandla is the pool to replenish the fire engine. The pool is equally to be used when the fire breaks out, by deploying the suction pump, linking it with monitors through fire hoses, in order to extinguish fire while the fire truck is on its way. This process is illustrated in the picture below.

6.2.15 The two fire hydrants at the private residence of the President in Nkandla and eight reel fire hoses that are installed there have either very low pressure or no water at all. It should be noted that the water supply to Nkandla by uThungulu District Municipality is erratic, has low pressure and at times runs out. (Video firefighting)

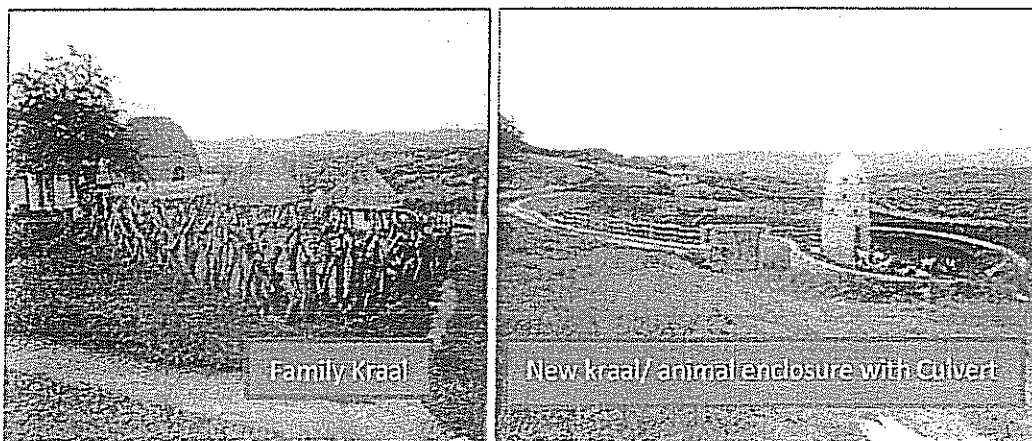
Figure 4: Family kraal and animal enclosure

6.3.1 The construction of a kraal and/or animal enclosure was regarded as a non-security feature by the Public Protector. The construction of the kraal and/or animal enclosure and the relocation of the animals is amongst others, discussed in the context of access control and Perimeter Intrusion Detection (PID) Fence Technology Management.

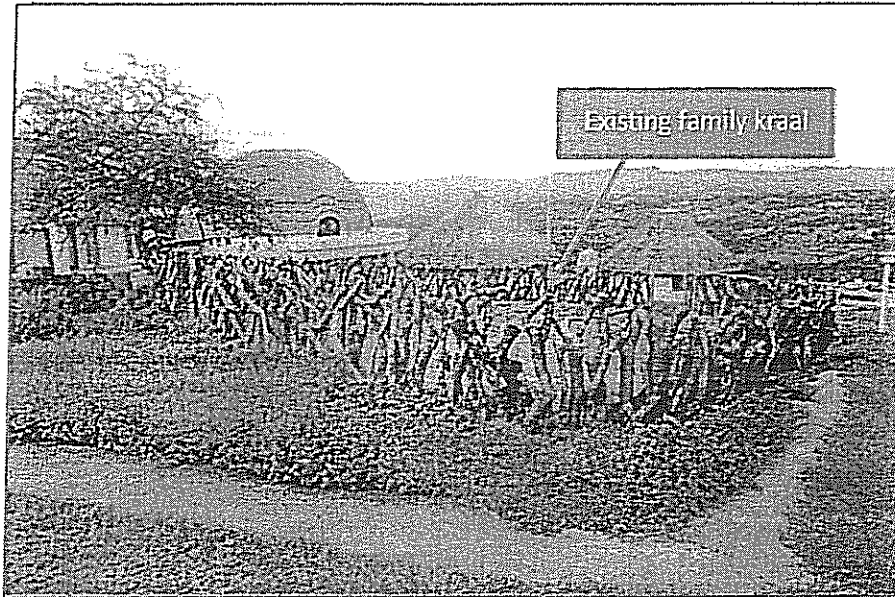
Figure 5: Existing family kraal

6.3.2.1 The President's residence has a kraal that the family built, which is at the centre of the homestead. The kraal has significant spiritual and cultural value that extends beyond the storage of animals. Essentially a kraal in its traditional sense is a spiritual and sacred place of a homestead as stated in the paragraph above. (Kraal interview)

6.3.2.3 Since the family kraal was/ or is located in the high security zone, the continuous use of the family kraal would interfere with the security motion detectors. It was recommended that the animals be relocated to the periphery of the homestead and outside the inner high security zone and within the outer perimeter security fence.

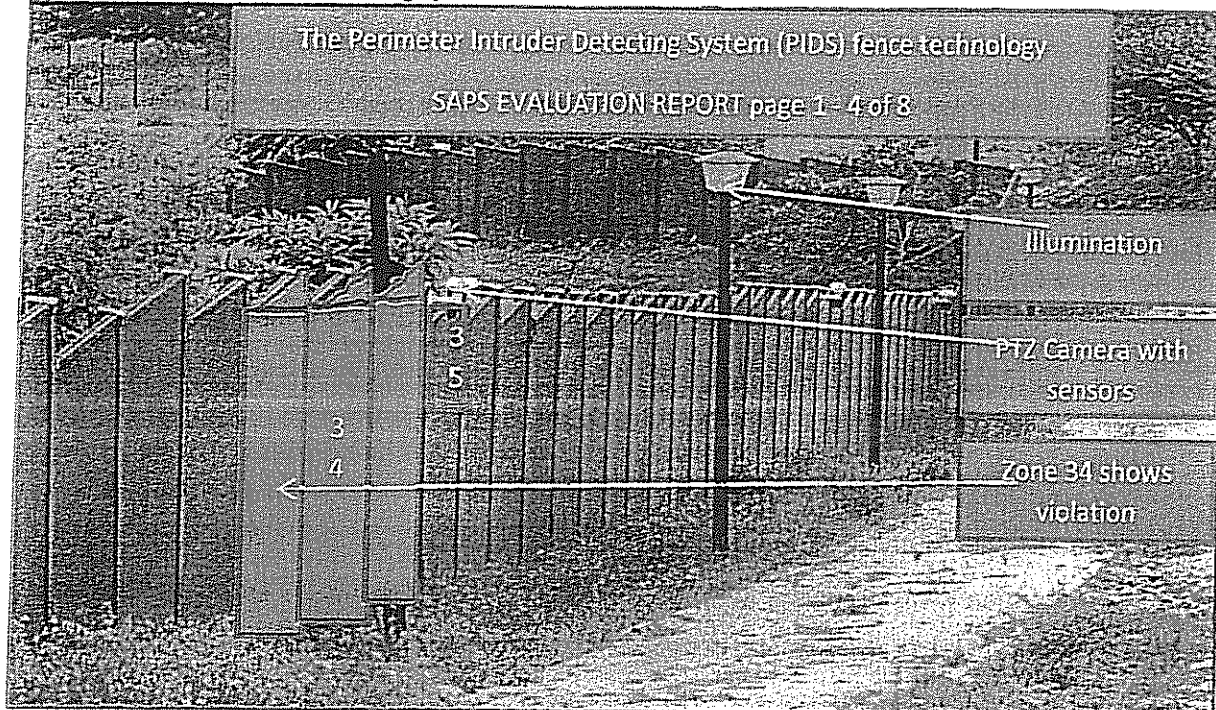
Figure 6: Perimeter Intruder Detecting System

6.3.2.2 The SAPS Security Evaluation Report on page 1 of 11 discusses perimeter protection and entrance gates with regard to perimeter protection. The security appraisal states that amongst others; there should be a brick and mortar wall erected and fitted with a six strand electric fence. The electric fence must be divided into zones and be interfaced with the proposed intruder alarm system as well as the CCTV camera system with analytics. The fence must have passive infra-red motion detectors placed strategically along the fence in sensitive areas (SAPS Evaluation Report, page 4 para 10).

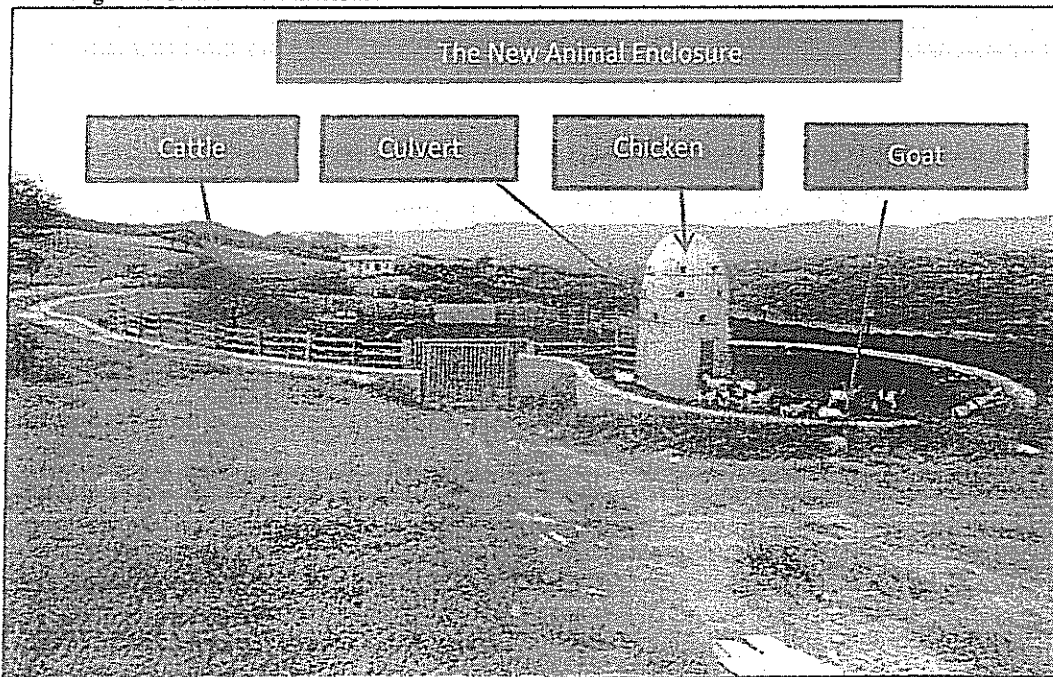
Figure 7: New animal enclosure

6.3.3.2 The new animal enclosure with culvert and chicken run was constructed in a remote location away from the high security zone or inner perimeter infrastructure so as to give effect to the fence technology and use thereof. The R&G Consultancy Report, page 28 par 9.6 states that *“the position of the kraal has been influenced by the new security line, culvert and internal security access road ...”*

6.3.3.3 The new animal enclosure complies with the security requirement that animals should be kept outside the high security zone and have an outlet, or culvert, that allows no interface between the livestock and the security infrastructure. The security infrastructure that should not interface with animals include the outer perimeter automated intrusion detecting fence and inner perimeter motion detecting beams as requested in the SAPS Security Evaluation Report page 5 of 8.

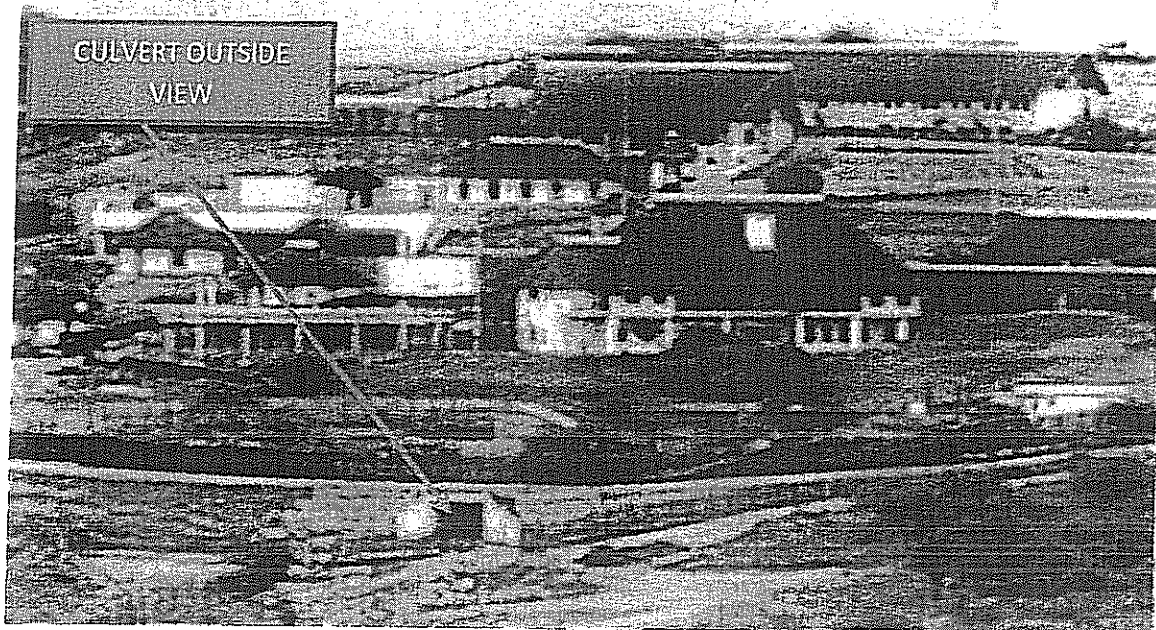
Figure 8: The culvert

6.3.4.1 The culvert channels the animals in and out of the new kraals and/or enclosure such that the outer perimeter security system (PIDS) as well as the inner perimeter's motion detection beams (MDB) is not interfered with, thereby avoiding interface and triggering false alarms.

6.3.4.2 A DPW Report dated June 2011 and titled "Motivations and cost allocation proposals no.4" provides the following motivation for the livestock culvert "...Livestock access in and out of the homestead is provided via an under pass punching through the high security fence. A trafficable cattle culvert pass under the fence and there are gates at both ends of the culvert. This was a security design consideration which allow for continuous flow of the high security fence with less false alarm on motion detection..."

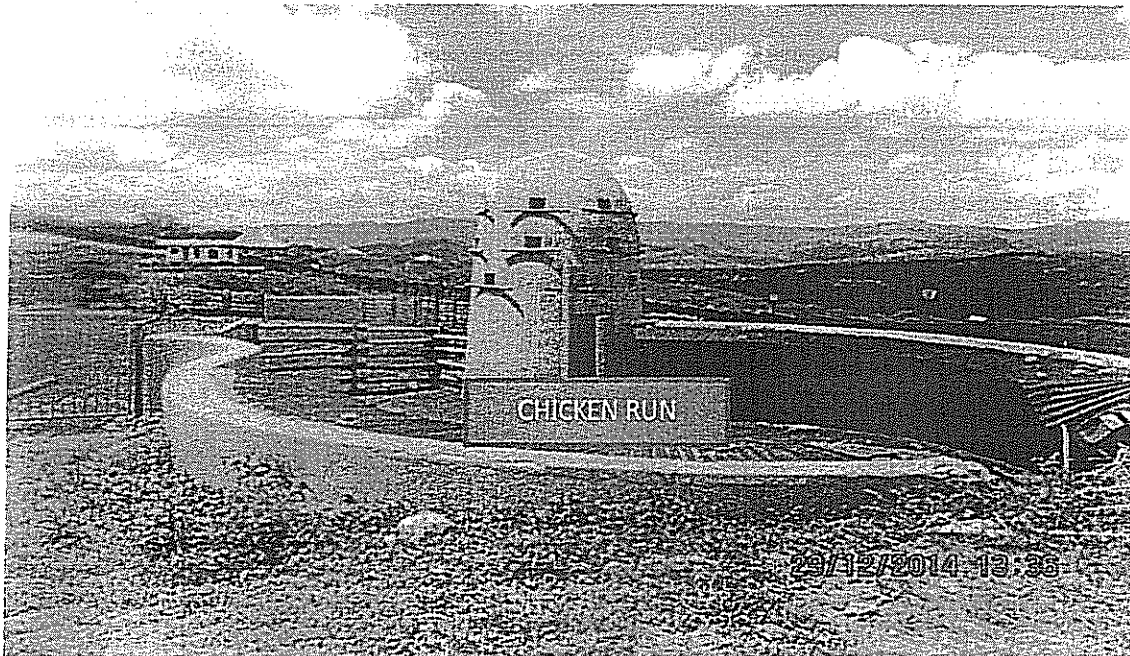
Figure 9: The chicken run

6.3.5.1 The sensors on the PIDS fence and motion detector beams (MDB) are very sensitive to the extent that they could easily be activated by free running chicken.

In this regard, free running chicken needed to be confined to a chicken run outside the high security zone and away from the Perimeter Intrusion Detection System (PIDS) fence technology.

6.3.5.2 Constant false alarms, possibly caused by animals or persons, result in a tendency by the security officers to either ignore any further alarms or simply switch off the system. It is for this reason that security practitioners recommended that the animals should be kept away from the outer and inner perimeter fence technology and be kept in the new enclosure with separate entrance and/or exit (culvert). (Video security appraisal & culvert)

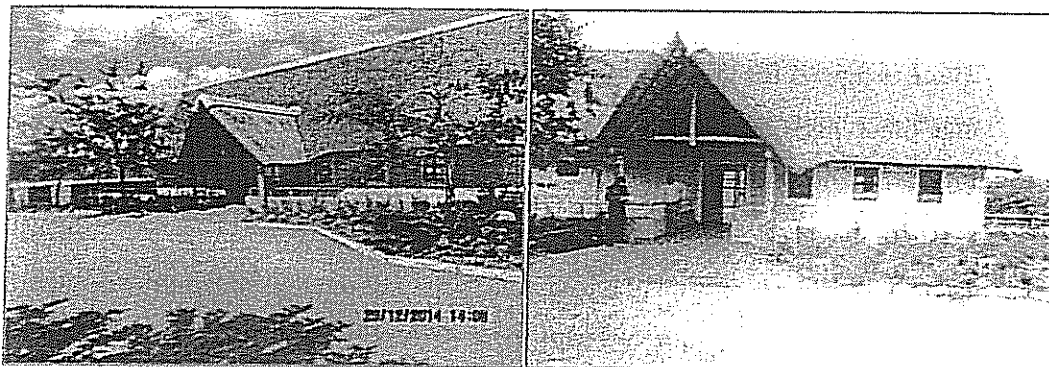
Figure 10: Visitors' Center

It should be noted that, according to the R&G Consultancy Report, the visitors' center and control room were requested by the SAPS. Further that the visitors' center on top of the SAPS control room.

6.4.1 The President of the Republic is also a Head of State in terms of the Constitution Chapter 5, section 83(a) and he continues to discharge his responsibilities even when at his residences. Such engagements include receiving and hosting Presidents from other Countries and high profile local and international guests.

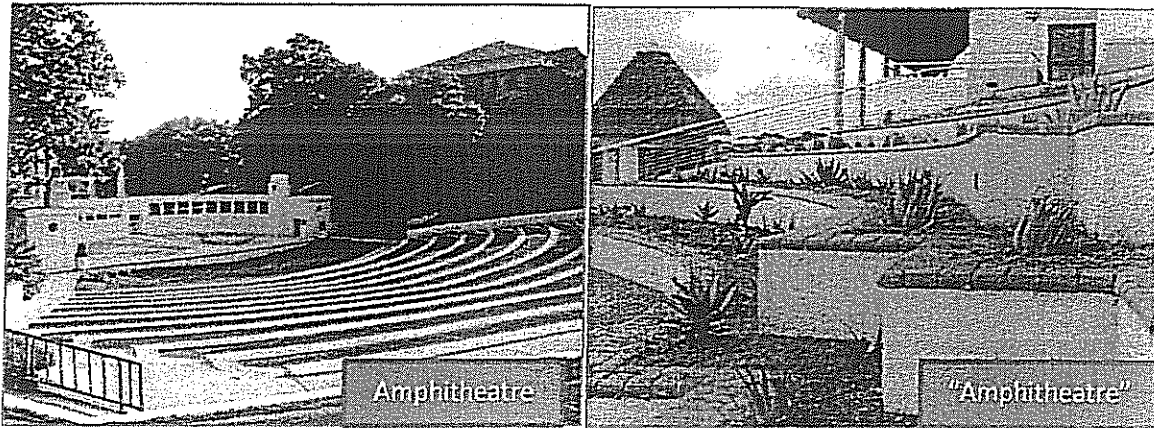
Figure 12: Amphitheatre vs the President's homestead

6.5.4 Below are pictures of what is referred to as an amphitheatre. The picture on the left is an amphitheatre designed for entertainment purposes. The picture on the right is what has been referred to as an amphitheatre at the President's residence in Nkandla. The civil engineering reports make reference to both an amphitheatre and a soil retention wall. Clearly the picture on the right does not resemble an entertainment area.

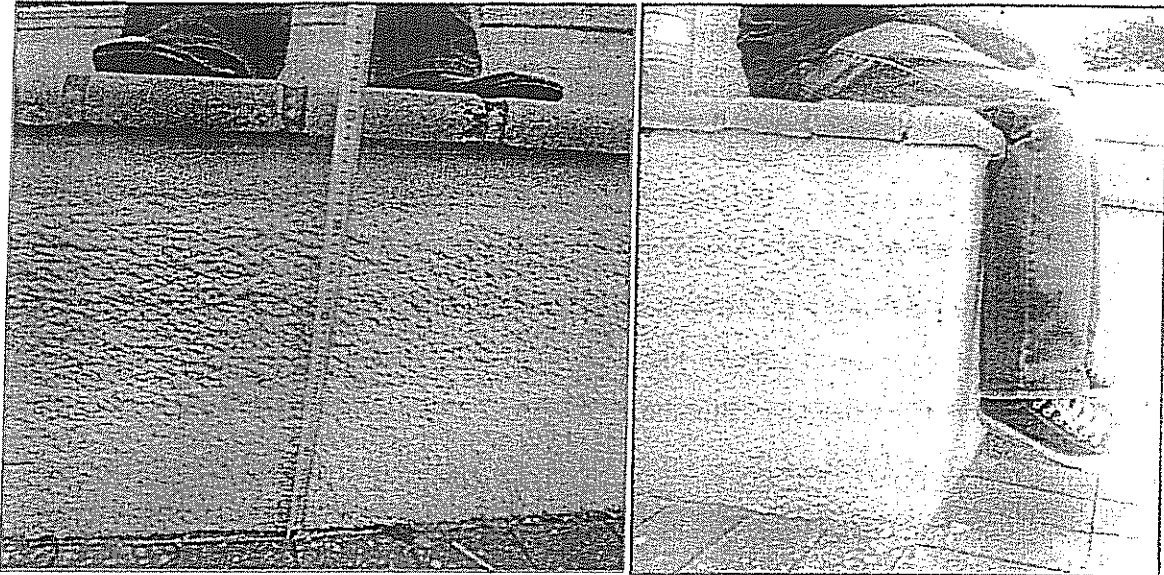
Figure 13: Walls not built for sitting

- 6.5.10 The height of the step is 0.65 meters whereas the horizontal platform or width is between 0.7m to 1.3meters. With illumination on the vertical walls, whereas if it was to be used as amphitheater there would have been people seated and obscuring the illumination. It would be unimaginable that people would be seated in an aloe garden with irrigation system; this could not be regarded as amphitheater under the circumstances.

6.5.11 The dwarf stepping soil retention walls are the best in terms of safety and security in that it avoids obscuring the view of security persons and does not provide a hideout for would-be intruders. The dwarf stepping walls are preferred in terms of strength and safety as opposed to steep sloping single soil retention walls that pose a danger to persons falling and breaking bones or falling to their death.

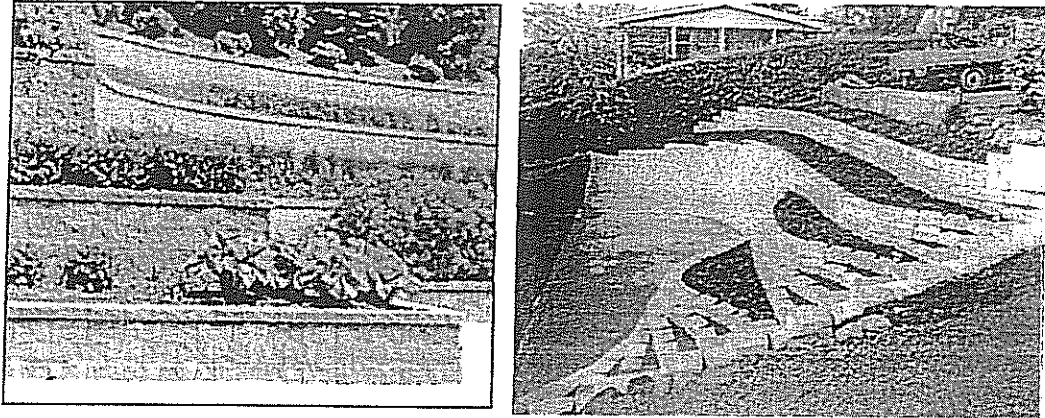
Figure 14: Stepping stone retention walls

6.5.12 The pictures below are regarded by landscape experts as the best and sustainable method of soil retention "Retaining walls prevent soil and substrate from moving because of erosion or gravitational pull" <http://www.soilretentionmethods.za>. These are also regarded in landscaping terms as Dwarf Wall Sloping Terrace.

6.5.13 The stepping up ground retention methods shown above are recommended as the best method, also regarded as stronger than single wall retention, single retention walls tend to curve in and crack due to geological and storm water pressure. The R&G Engineers Report stated under the heading 'Landscaping' on page 21 that, "*....retaining walls were required due to the new security access road infrastructure ....*"

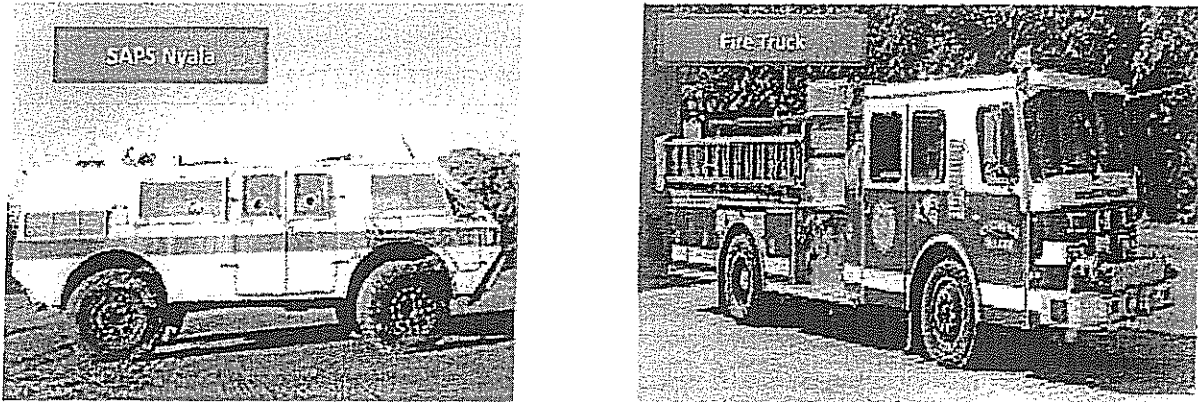
Figure 15: Heavy duty vehicles

6.5.14 The retention wall at the private residence of the President in Nkandla had to be strong and stepping in order to retain ground that carries the main homestead internal road. The positioning of dwarf walls sloping terrace assist in retaining the soil which carries the upper road surface. The upper road is used by heavy duty vehicles as illustrated below. This includes heavy fire fighting trucks, armored personnel carrier, SAPS Nyala armored personnel carrier and VIP vehicles.

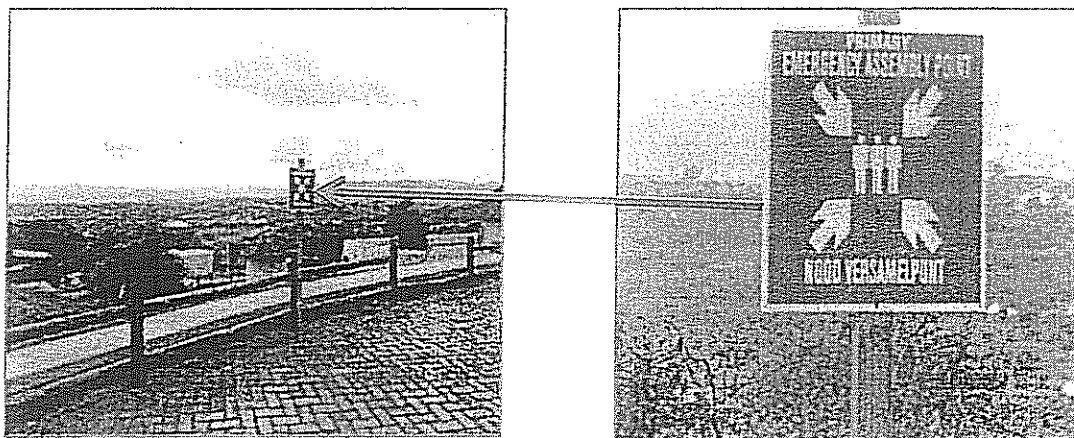
Figure 16: Emergency assembly point

6.6.2 In case of major security emergencies, security drills and demonstrations by law enforcement officers; as well as emergency services would be able to assemble for briefing and debriefing at this particular zone.

- 6.6.3 The homestead is occupied by a number of people as well as the family members of the President. In case of any fire threats, bomb threat or medical emergencies the occupants of the homestead would assemble at this particular area referred to as “amphitheatre”. This area has appropriate signage and thus provides illumination linked to the electrical mains, as well as the backup generators. The linkage of this area to the back-up generator is in line with the SAPS Security Evaluation Report, page 7 of 8 which states that; “...the proposed new generator must be able to supply enough power to cater for both domestic and security needs within the premises...”

- 6.6.4 The existence of the assembly area complies with the Occupational Health and Safety Regulation which requires that any dwelling occupied or used for office or accommodation by a number of people should have such an area in order to take stock of the occupants and their conditions during emergency. (video amphitheatre)
