**REPORT BY THE MINISTER OF POLICE TO  
PARLIAMENT ON**

**SECURITY UPGRADES AT THE NKANDLA PRIVATE  
RESIDENCE OF THE PRESIDENT**

**25 March 2015**

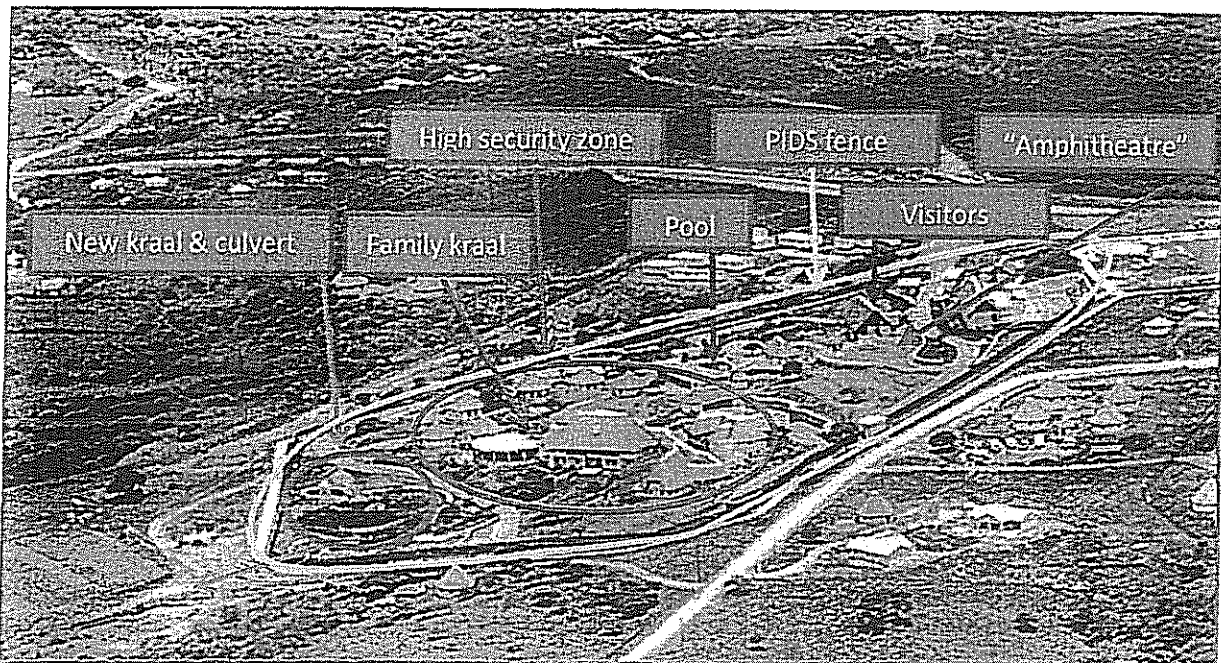
Figure 1: The aerial picture of the Nkandla Homestead

3.6 The picture below depicts the layout of the entire private residence of the President in Nkandla from an aerial point of view. This aerial view shows the high security zone in red, the outer perimeter fence in yellow, and the blue points to the actual location of the features in dispute.

The black steel fence around the homestead is the outer Perimeter PIDS fence. Below the inner lower road are the new kraals with culvert and chicken run. All houses below the swimming pool and lower road are located in the high security zone. The high security zone would be protected by Motion Detection Beams

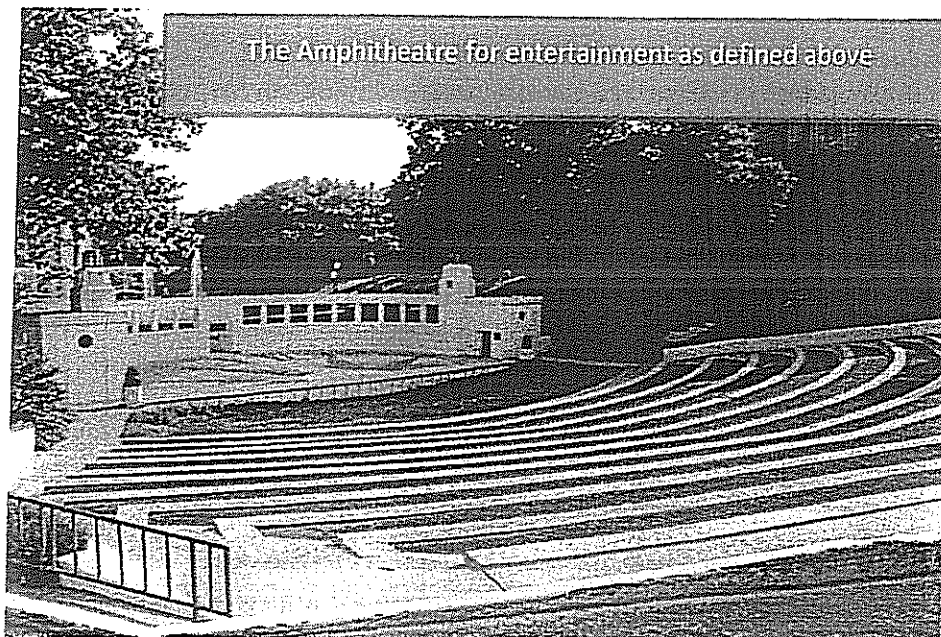
Figure 11: Amphitheatre

6.5.2 The Parliamentary Adhoc Committee observed that *“The land on which the President’s private residence has been developed lies at a gradient of 40 to 70 degrees which makes it more susceptible to flooding during storms. Due to the gradient, all construction activities such as earthworks and landscaping had to include fortifications, buttresses and paving for proper water flow and storm water drainage.”*(Parliamentary Ad Hoc Committee, 2014:2963, para 3.32 and 3.33).

6.5.3 As a result of the above, a number of soil retaining walls had to be constructed at the private residence of the President in Nkandla to hold the soil and substrate against gravitational pull and storm water. In this context, the soil retention wall also carries an access road on top, which is used by heavy security vehicles for purposes of work within the homestead.
