FOREWORD

1. EXECUTIVE SUMMARY

2. NATIONAL RAPID ENVIRONMENTAL ASSESSMENT - INDONESIA

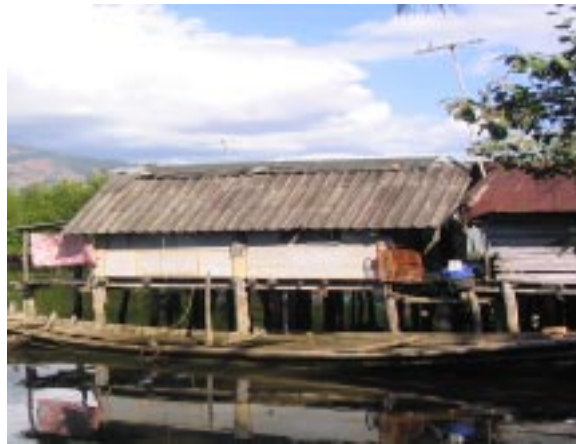
Khura Buri, Phang Nga Province, Thailand (January 2005). Small fishing village unaffected by the tsunami thanks to the protection of mangrove forests (location "2" on the map).

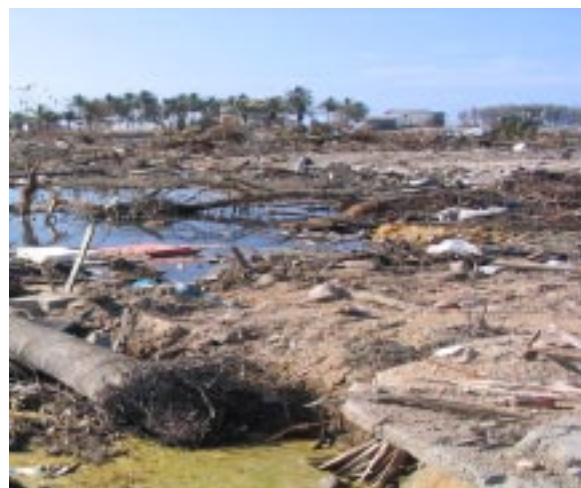
Phang Nga Province, Thailand (January 2005). Coastal area not protected by mangrove forests and severely impacted by the tsunami (location "1" on the map).

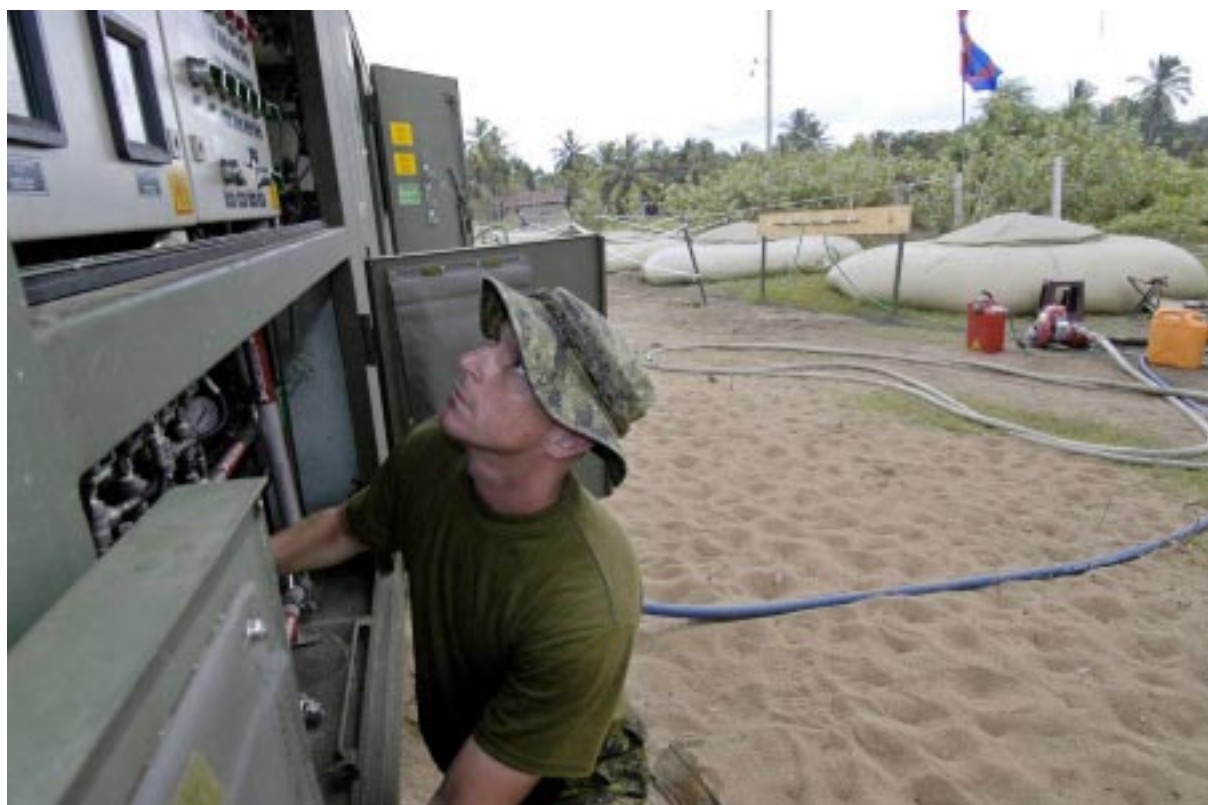
Kalmunai, Sri Lanka (3 February 2005). Checking the water purification machine in Sri Lanka's eastern town of Kalmunai. A 200-member Canadian military contingent is conducting relief operations on the east coast, providing clean drinking water for 80,000 tsunami survivors. © Prakash Singh/AFP/Getty Images

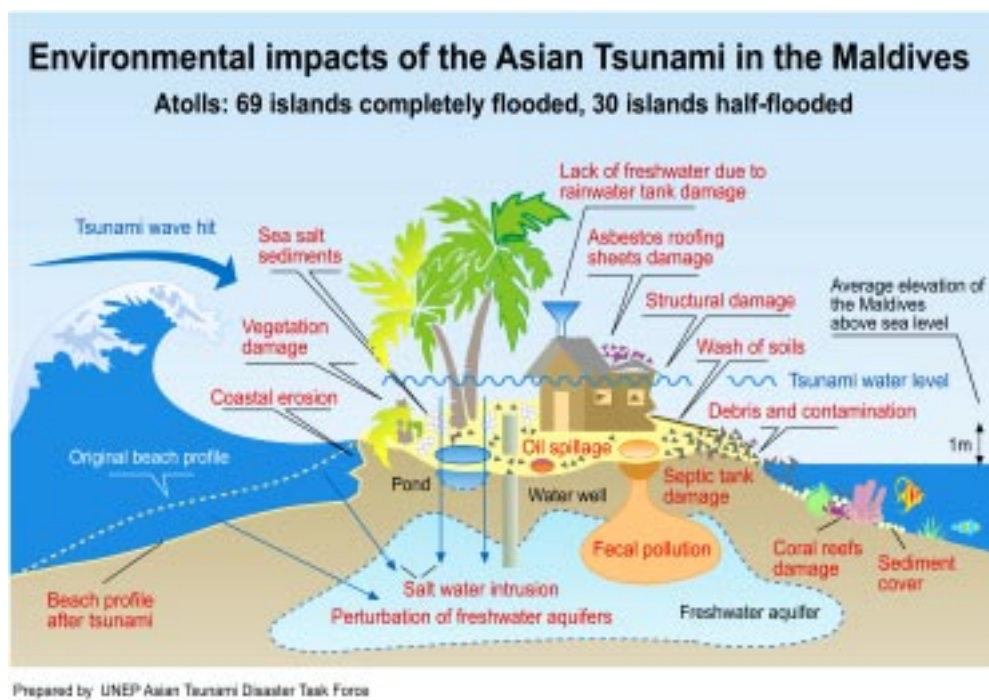
Case study: Groundwater contamination in the Maldives

The tsunami caused extensive groundwater contamination in 69 affected islands in the Maldives. Seawater with high conductivity infiltrated the islands' shallow aquifers and combined with sewage from destroyed septic tanks and sewer systems. Sea outfalls close to shorelines were damaged, causing further leakage into the aquifers. Investigations found waste and hazardous substances, such as spilled oil, near groundwater wells, most of which are unprotected and vulnerable to contamination. Initial sampling found bacteriological contamination in all groundwater samples.
