UPDATE : ESKOM ELECTRICITY SUPPLY

03 April 2019

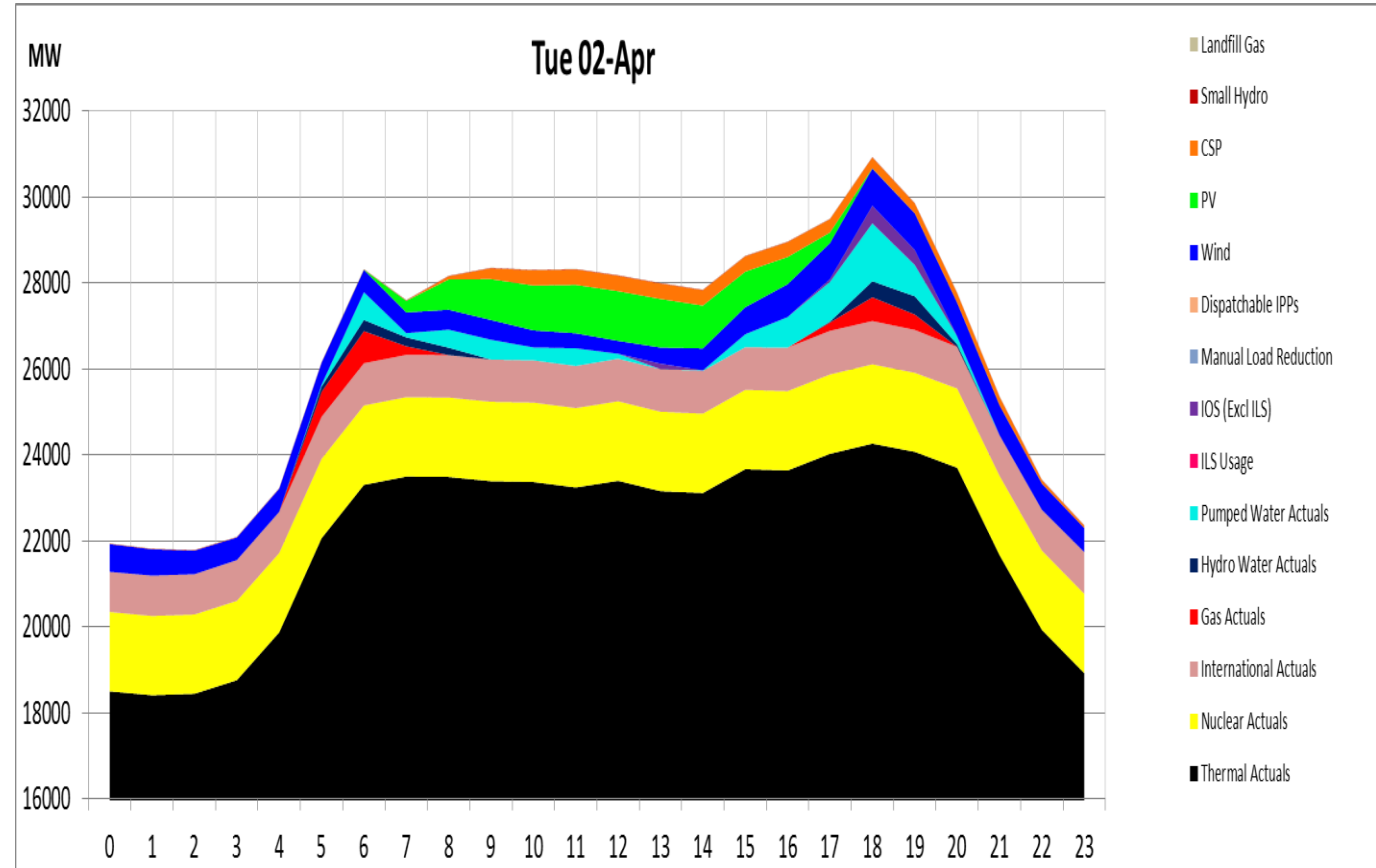
Eskom was able to meet demand on 2 April with existing capacity

Residual Demand breakdown (MW) during evening peak on 02 Apr 2019	
Eskom Coal (1669 MW from non-commercial units)	24 273 MW
Eskom Nuclear	1 845 MW
Eskom Hydro	1 716 MW
Eskom OCGT + GT	546 MW
International Imports	1 009 MW
IPP OCGT	0 MW
Virtual Power Station	409 MW
Total	29 798 MW

8500 MW unplanned maintenance

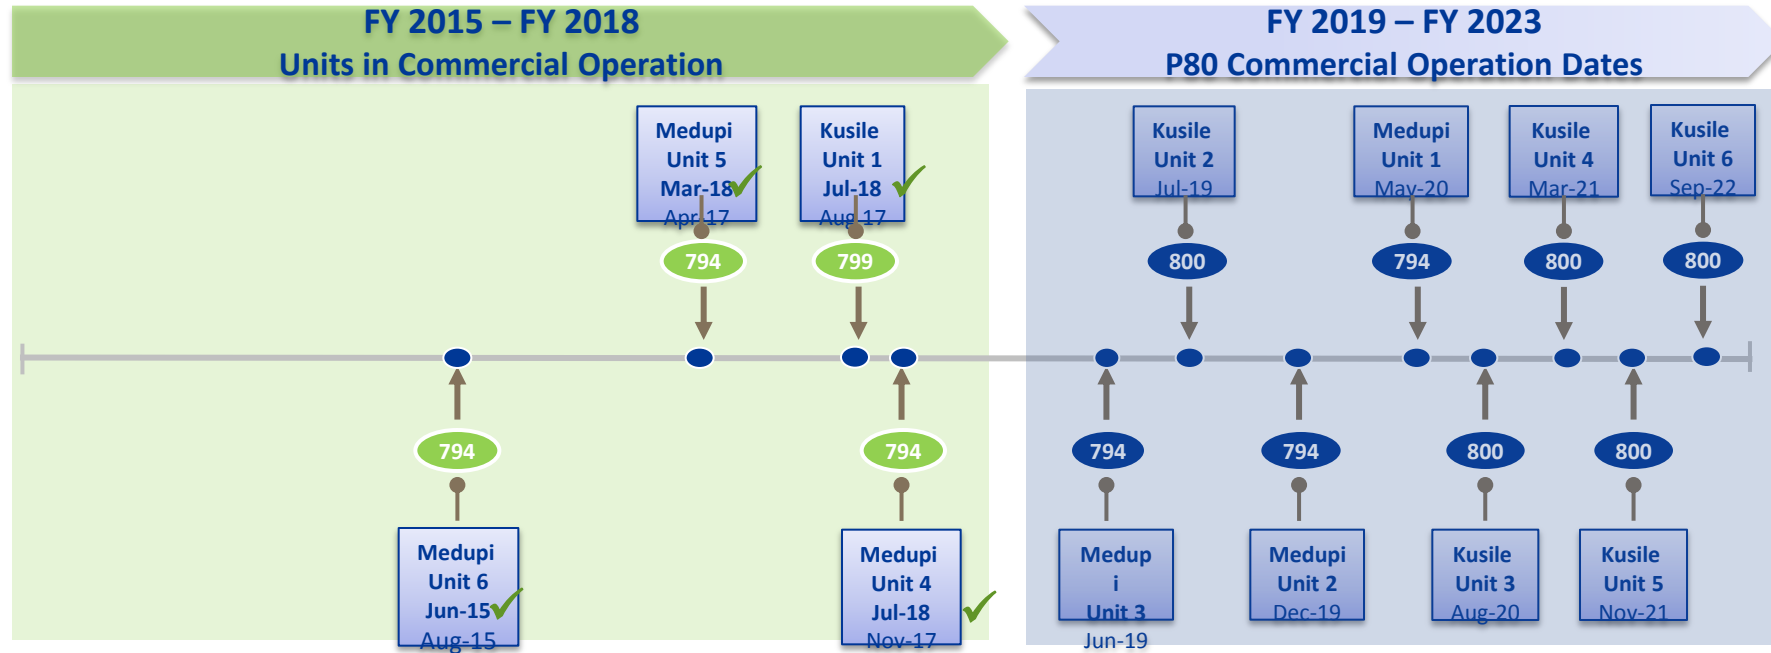
Kusile and Medupi new build programme on track with the schedule

Progress as of Feb 2019

Unit 6	Unit 5	Unit 4	Unit 3	Unit 2	Unit 1
		CO	CO	CO			
MEDUPI	Latest Progress	100%	100%	100%	99.83%	99.04%	88.54%
		Unit 1	Unit 2	Unit 3	Unit 4	Unit 5	Unit 6
		CO					
KUSILE	Latest Progress	100%	99.50%	97.60%	83.80%	73.60%	65%
